# Preservation Tech Notes

## WINDOWS NUMBER 22

### Maintenance and Repair of Historic Aluminum Windows

**Kaaren R. Staveteig**  
Technical Preservation Services  
National Park Service

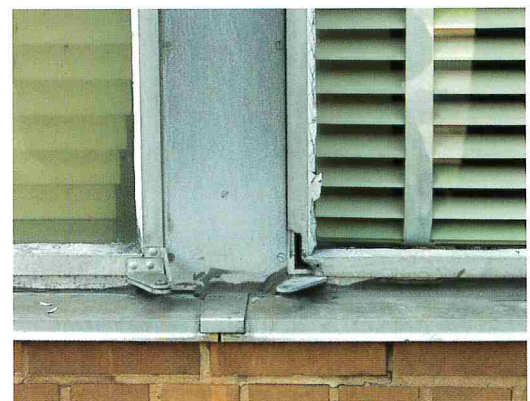
*Figure 6. Deferred maintenance can result in a series of problems, such as broken hardware, cracked or missing glazing putty, and missing perimeter caulk (all shown above). All of these problems can be corrected. Note the uneven nature of the surface deposits of pollutants and grime on the mullion and sill of this window due to weathering and lack of cyclical cleaning.*

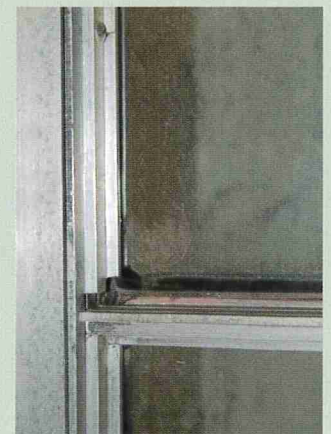
*Figure b. The panes of glass were secured into the frame with aluminum glazing stops, each individually cut, drilled, and fixed in place from the inside. Here the vertical stop is in place while the horizontal is missing.*

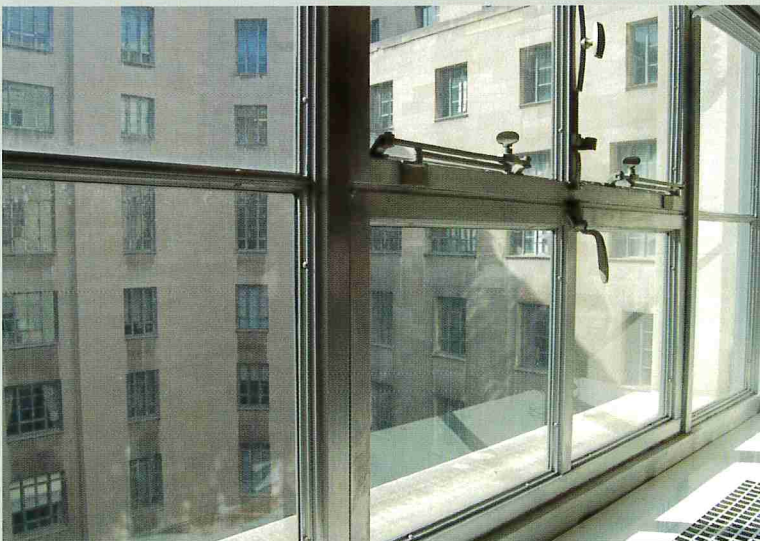
*Figure c. In cleaning historic aluminum windows, the gentlest means possible should be used. More aggressive cleaners should be used only where necessary. The interior surface of this window was cleaned ten years ago with an aluminum jelly cleaner, rinsed and then dried thoroughly. The original mill finish still retains its luster.*

needed. The aluminum was then rinsed to remove the cleaner residue (Figure c). For the exterior surfaces of windows that were more heavily corroded, the aluminum restoration company proposed a more aggressive chemical cleaner be used. This necessitated that the surrounding limestone surfaces around each window be well protected. During a mockup cleaning exercise, this chemical cleaner proved too acidic, difficult to control, and damaging to the adjacent stone. After testing some alternate products, the team found that a diamond abrasive pad used in combination with the Duro Aluminum Cleaner in jell form, worked the best. Special care was still necessary to protect the surrounding limestone.

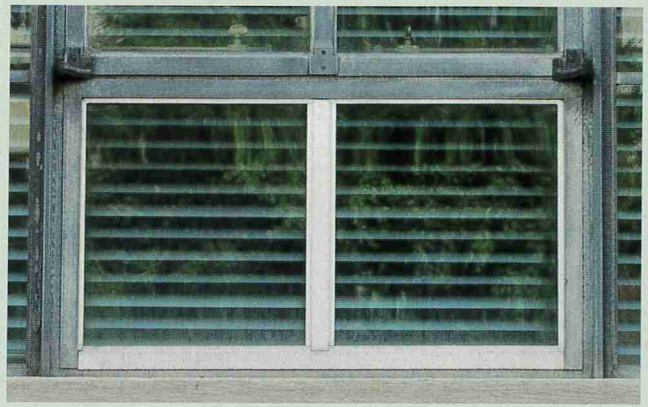
*Figure d. Numerous hopper units have been removed over time to accommodate air conditioning units. Replacement hopper units were manufactured, as needed, to match the original hoppers elsewhere in the building.*

An aluminum company reproduced the vertical muntin that historically existed in the hopper unit but was missing from numerous units. After the muntins were cut to size, each was slotted at the end and fitted into the hopper frame, and then welded at the tip. The same company also made custom extrusions for the rails and stiles of the hopper units for use in fabricating entire hoppers where missing (Figure d).

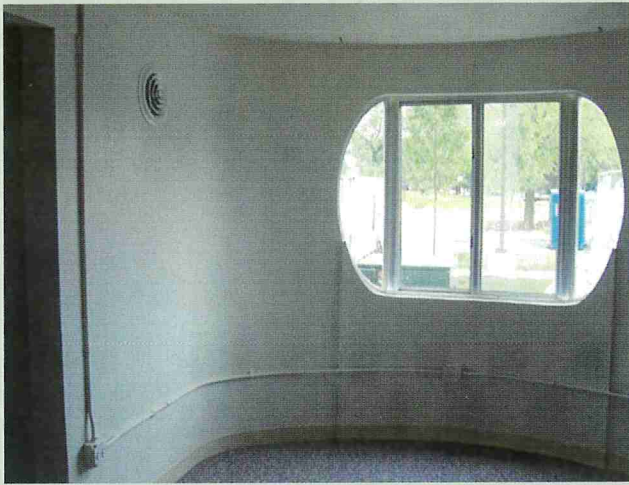
*Figure e. Both interior and exterior aluminum surfaces had become dull, soiled, and oxidized as a result of traffic exhaust and air pollution. Cleaning the aluminum stabilized any further deterioration and brought back the luster of the original mill finish. (Photo: Holsten Real Estate Development Corp.)*

denatured alcohol were used to remove the general residue on the aluminum. Wearing rubber gloves, the crew wiped on the cleaner with a damp cloth, allowed it to stand for 3-5 minutes, and then wiped it off with a clean damp cloth. Scouring pads and scrapers were sometimes used on more encrusted areas, as needed. The removable sash units were cleaned in the basement shop, while any frames that remained in situ were cleaned in place (Figure e).

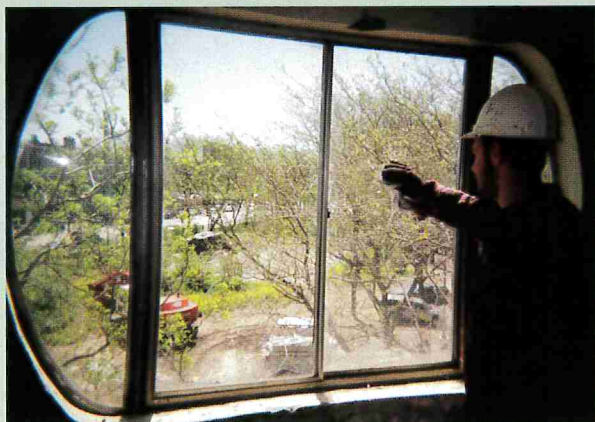
*Figure f. Repair and replacement work was done from the inside to lessen the risk of damage to the outside finish. (Photo: Holsten Real Estate Development Corp.)*
